Manhole Inspection Summary

Manhole # S45G2_014MH

Insp Date: **1/7/08 8:20 AM**

Location Address: **1400 Filbert St**

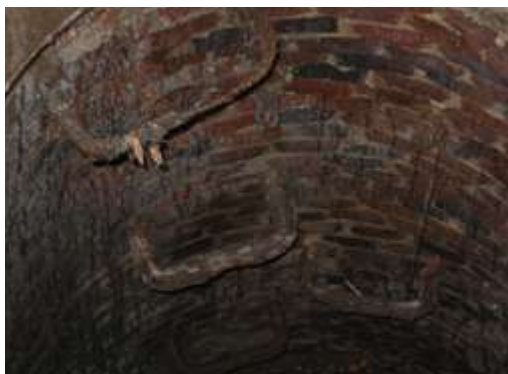
Steps Count: **5** Missing: **1** ☒ Corroded

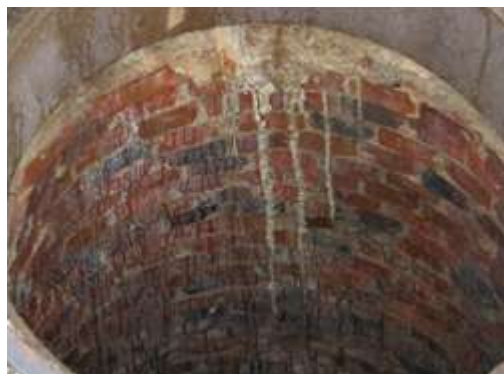
Defect 1

Infiltration: ☐ None ☐ Joint ☐ Cracks ☐ Mortar ☐ Roots ☒ Wall

Infiltration

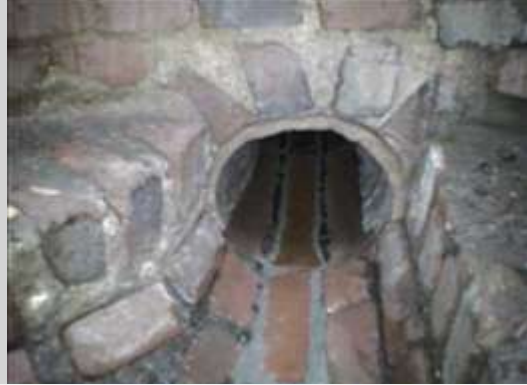
12 O'Clock Outflow

8 in. Circular Gravity Sewer
Pipe Out @ 12 O'Clock

Pipe Height: **9.6** (in.) Rod and Bar (Angled)
Pipe Material: **Clay** ☐ Pipe Lined
Invert Depth: **8.93** (ft.) Flow Characteristics: **Fast**
Deposits: ☒ None ☐ Mud ☐ Sludge ☐ Debris ☐ Grease
Silt Depth: (in.) Deposits Extent:
Infiltration: **None** Pipe Seal Cond: **Sound**

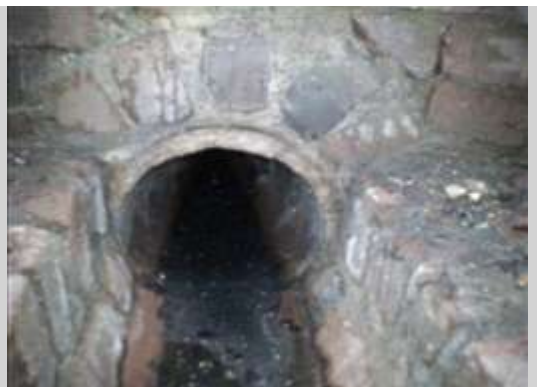
6 O'Clock Inflow

6 in. Circular Service Sewer
Pipe In @ 6 O'Clock

Pipe Height: **8.4** (in.) Rod and Bar (Angled)
Pipe Material: **Clay** ☐ Pipe Lined
Invert Depth: **8.96** (ft.) Flow Characteristics: **Slow**
Deposits: ☒ None ☐ Mud ☐ Sludge ☐ Debris ☐ Grease
Silt Depth: (in.) Deposits Extent:
Infiltration: **None** Pipe Seal Cond: **Sound**

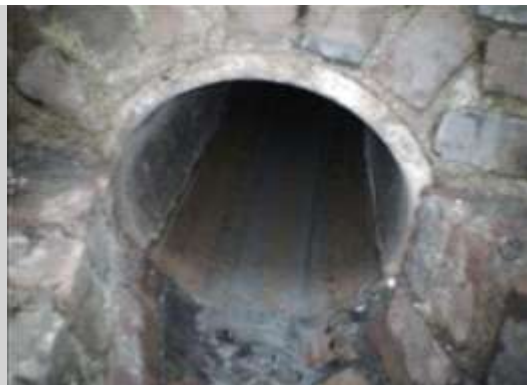
9 O'Clock Inflow

10 in. Circular Gravity Sewer
Pipe In @ 9 O'Clock

Pipe Height: **10.8** (in.) Rod and Bar (Angled)

Infiltration: **None** Pipe Seal Cond: **Sound**
